# Manhole Inspection Summary

Manhole # S21GG\_001MH

Insp Date: **6/15/07 12:14 PM**

**Location** Address: **1700 BRUCE CT**

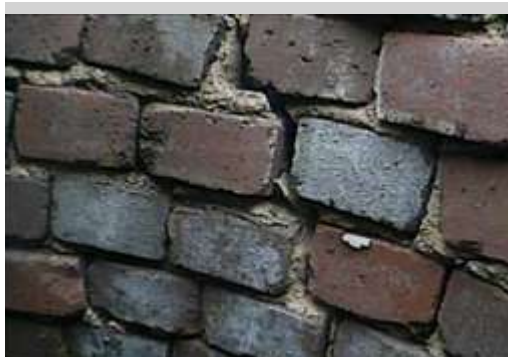
Defect 4

Comments **CORBEL HAS HUGE CRACK,**

Condition: ☐ Sound ☒ **Cracked** ☐ Root Intrusion ☒ **Loose Brick** ☐ Deteriorated

HUGE CRACK ON CORBEL AND  
LOOSE BRICKS

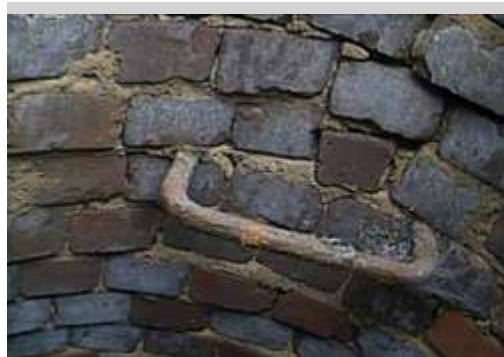
Defect 3

Count: **4** Missing: **0** ☒ **Corroded**

CORRODED STEPS

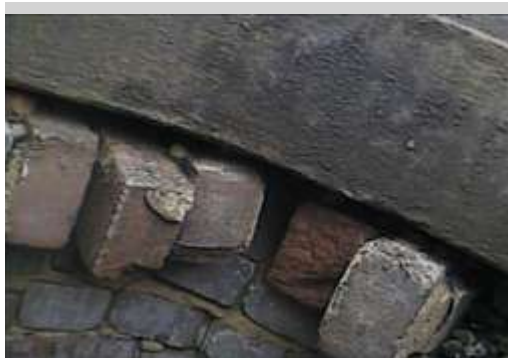
Defect 2

Condition: ☐ Sound ☐ Cracked ☐ Root Intrusion ☒ **Loose Brick** ☐ Deteriorated

LOOSE CHIMNEY BRICKS

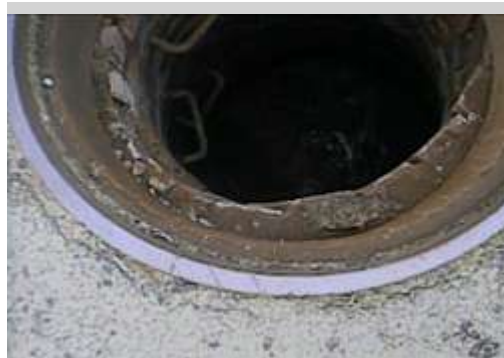
Defect 1

Offset: **3** (in.)

FRAME OFFSET

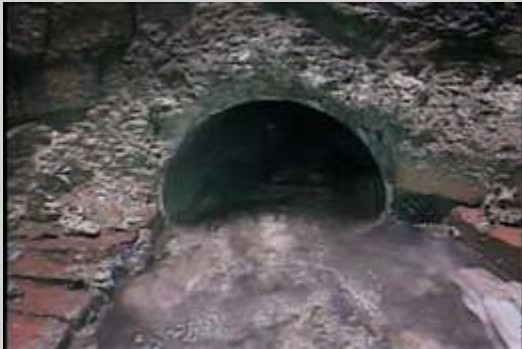
12 O'Clock Outflow

Pipe Height: **10.8** (in.) Rod and Bar (Angled)  
Pipe Material: **Clay** ☐ Pipe Lined  
Invert Depth: **9.15** (ft.) Flow Characteristics: **Slow**  
Deposits: ☐ None ☐ Mud ☐ Sludge ☒ **Debris** ☐ Grease  
Silt Depth: **3** (in.) Deposits Extent: **Light**  
Infiltration: **None** Pipe Seal Cond: **Sound**
